Waterhammer Event in Alumina Refinery Causes Catastrophic Slurry Pump Failure

14th International Conference on Pressure Surges
April 12-14, 2023 | Eindhoven, Netherlands

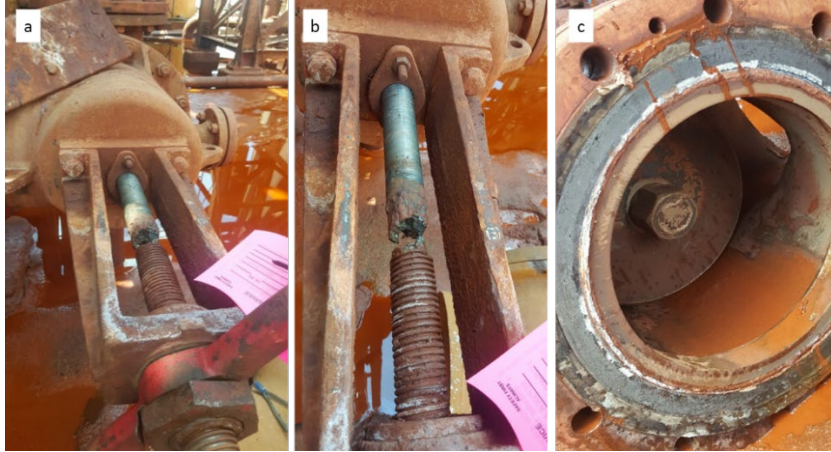
Figure 6. Broken stem in #3 DBO Pump Discharge Valve after removal (View #1) – see valve disc inside body in (c) photo at right

The #3 DBO Discharge Valve (an angle valve) had failed three times in the past and its spindle had been welded together each time.

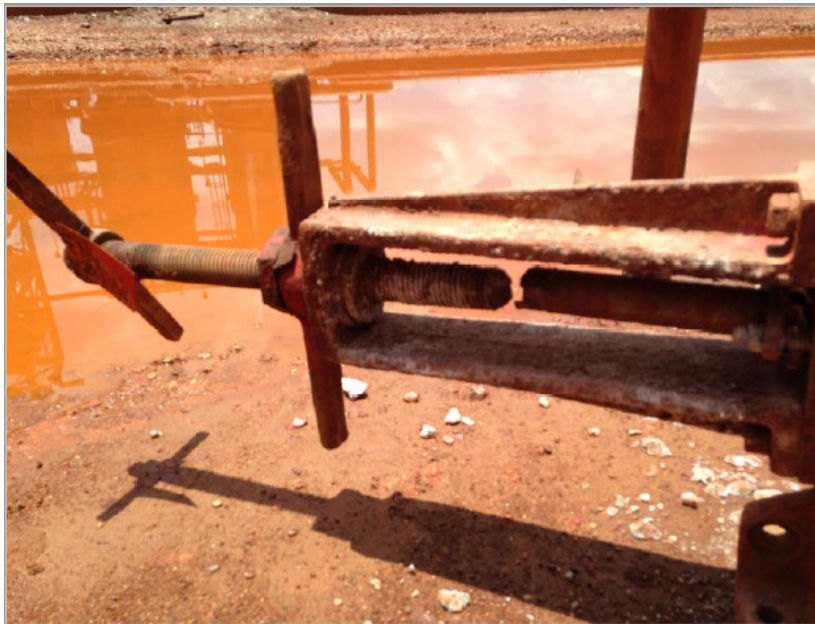
Figure 7. Broken stem in #3 DBO Pump Discharge Valve after removal (View #2)

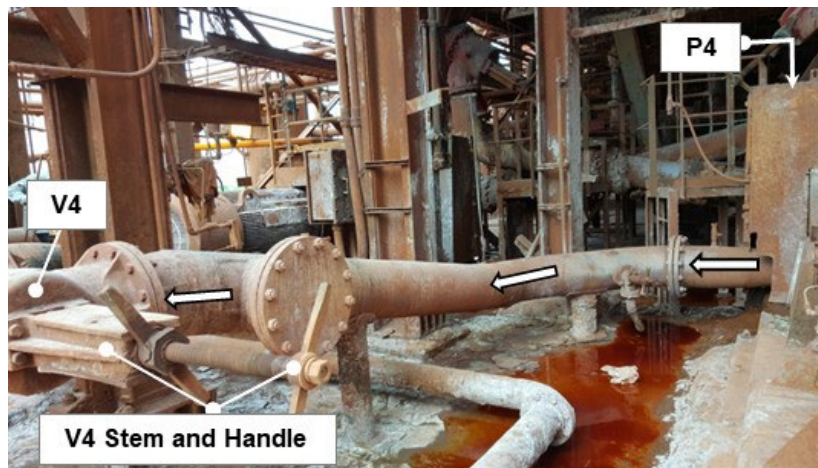
Figure 8. Undamaged #4 DBO Pump discharge piping and #4 Valve with flow direction arrows (for reference)

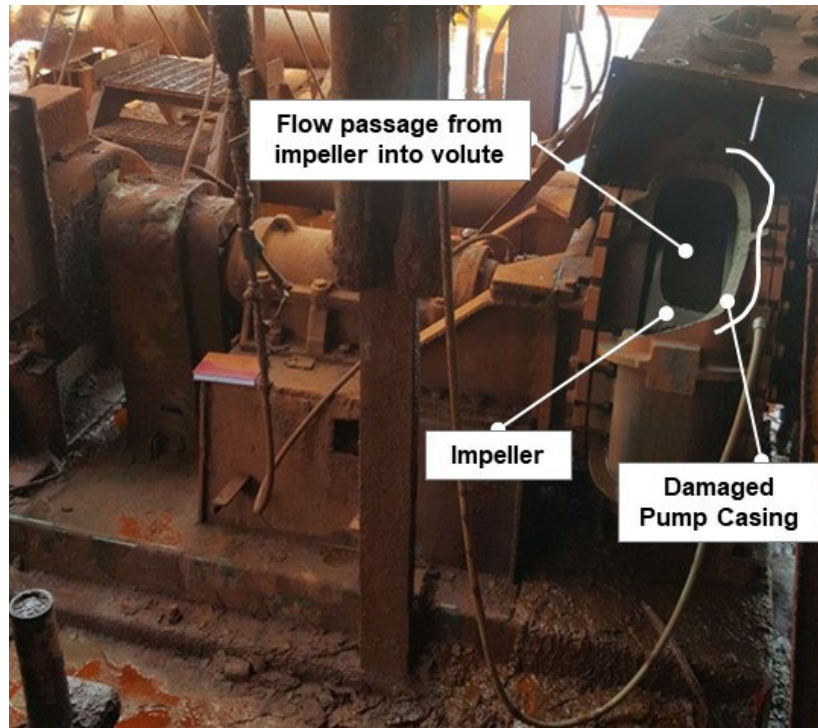
Figure 9. #3 DBO Pump failed casing in installed position

A catastrophic pump failure resulted from a combination of pump casing material properties, the caustic slurry high temperature process, pump operational and maintenance philosophy, and a failed valve which caused a waterhammer event. A waterhammer model shows the pressure at the pump discharge could have been as high as 100 bar (1400 psi). The pump was rated to a maximum pressure of 6.9 bar-g (100 psig).

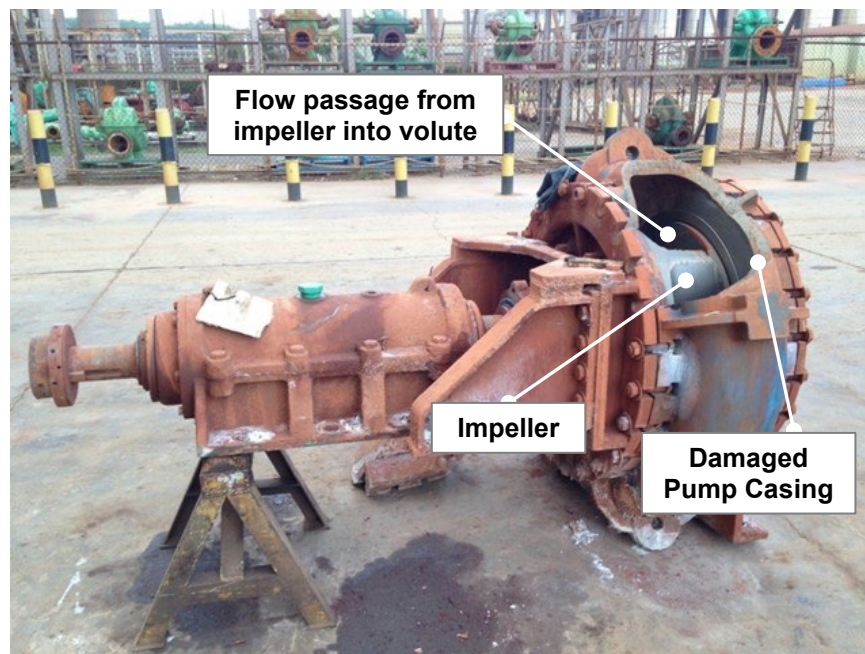
Figure 10. #3 DBO Pump failed casing after removal – see sawhorse for scale

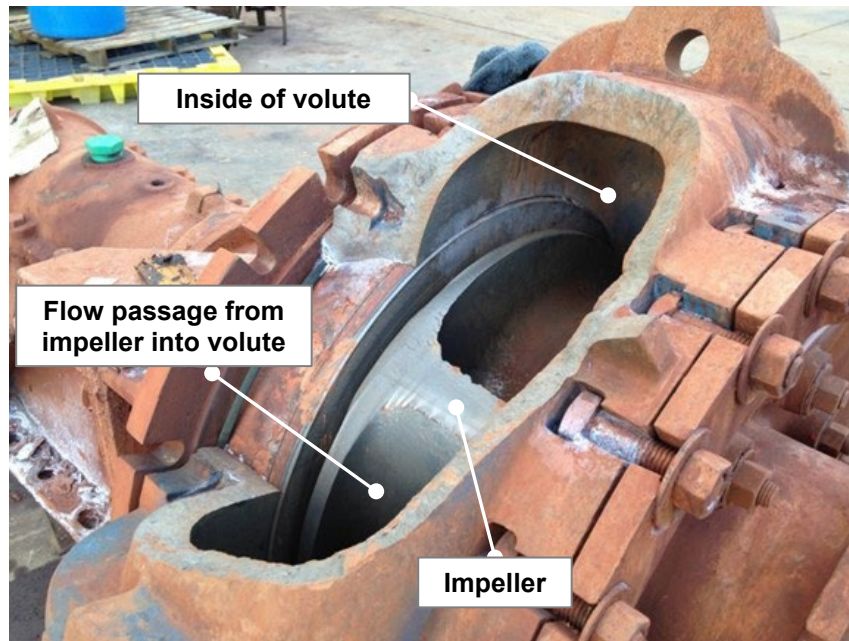
Figure 11. #3 DBO Pump failed casing close up

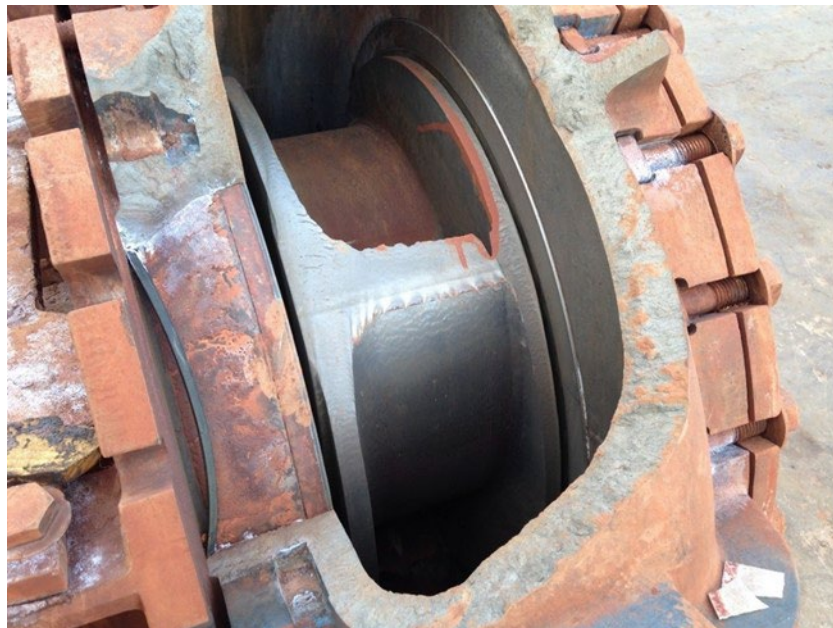
Figure 12. #3 DBO Pump failed casing close up (different angle)

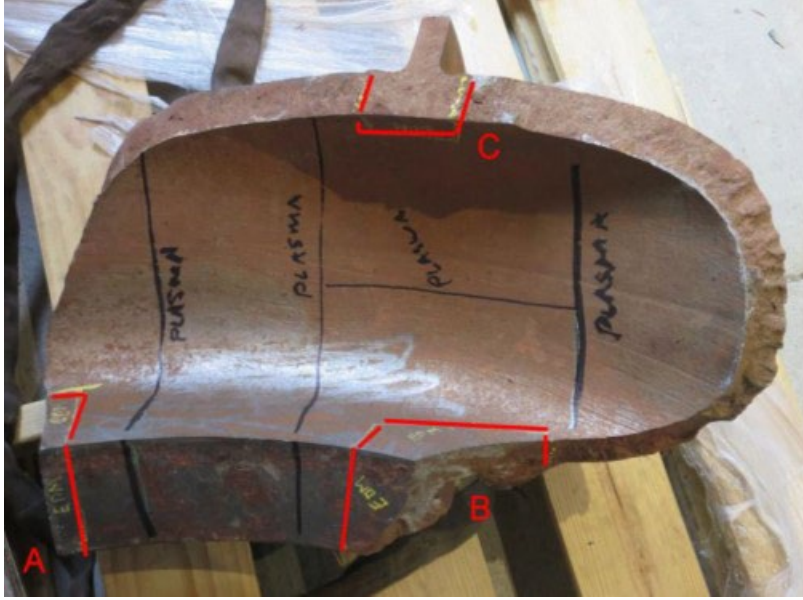
Figure 13. #3 DBO Pump fractured casing piece prepared for independent lab mechanical and metallurgical testing

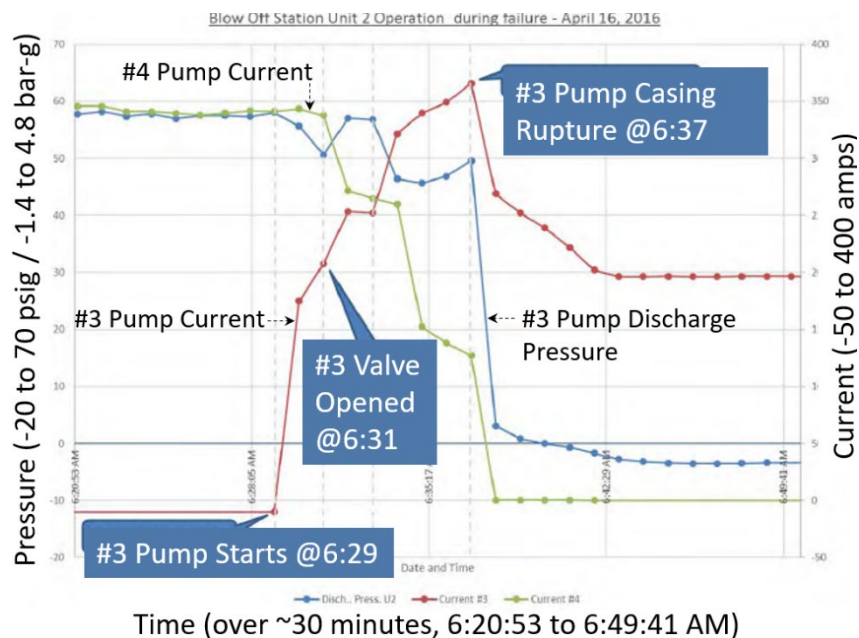
Data acquisition rates were low frequency which is typical in plants (data were logged roughly once per minute). Hence no data exists that captured the high speed transient that occurred. Instead, steady-state data was used to calibrate the initial conditions of the model discussed below. See Fig. 14 for some of the acquired data.

Figure 14. Graphics of Unit # 2 Snap Shot DCS Data for Pressure and Amperage at Time of Casing Explosion

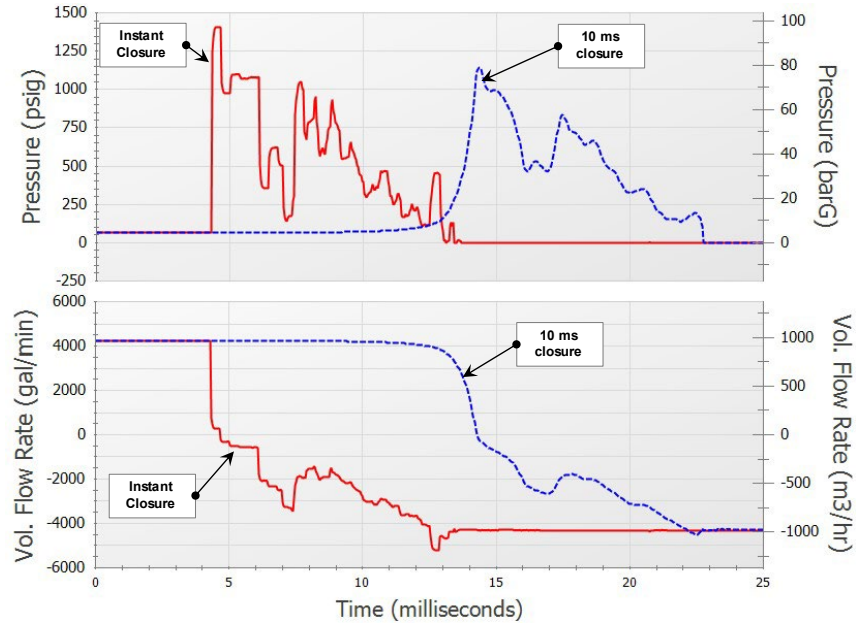
Fig. 16 shows predicted pressures and flow at the #3 DBO Pump discharge flange for valve instant and 10 ms closure cases. Here one can see the maximum predicted pressure was about 1,400 psig (98 bar-g) and 1,150 psig (81 bar-g) for the two cases. Not shown is the 100 ms valve closure case where the peak pressure was about 450 psig (31 bar-g). All of these far exceeded the 100 psig (6.9 bar-g) MAWP.

Figure 16. Predicted #3 DBO Pump discharge pressure and flow vs. time for instant and 10 ms valve closure.

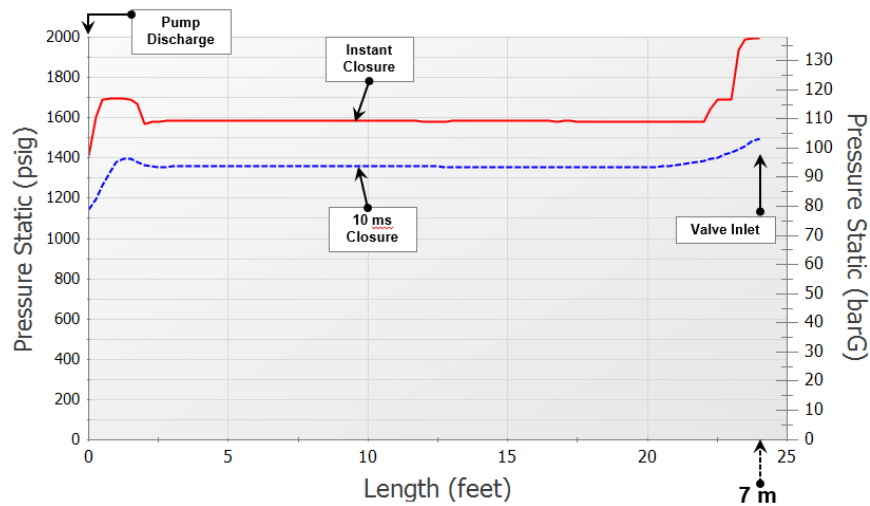
Fig. 17 shows the maximum pressure profile including later times after transient cavitation has occurred.

Figure 17. Predicted #3 DBO Pump discharge line maximum pressure profile from pump discharge to valve inlet for instant and 10 ms valve closure.
