Waterhammer Event in Alumina Refinery Causes Catastrophic Slurry Pump Failure

14th International Conference on Pressure Surges
April 12-14, 2023 | Eindhoven, Netherlands

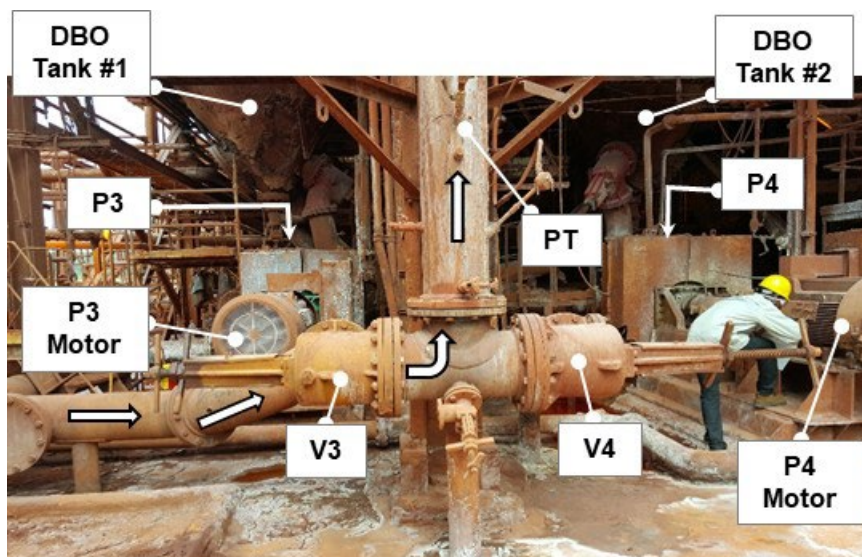
Fig. 4 shows the DBO Unit 2 tanks, pump locations, valves and piping. The pumps are not visible in this photo as they are behind the metal screens. Fig. 5 shows an expanded view of the photo with more detail on the #3 Discharge Valve. The disc is inside the valve body and as it moves to the right (in this photo) it will close the valve.

Figure 4. Unit 2 DBO tanks, pumps and valves (see technician for scale) with flow direction arrows on #3 DBO piping – this view is when system is properly operating. See Nomenclature for abbreviations.

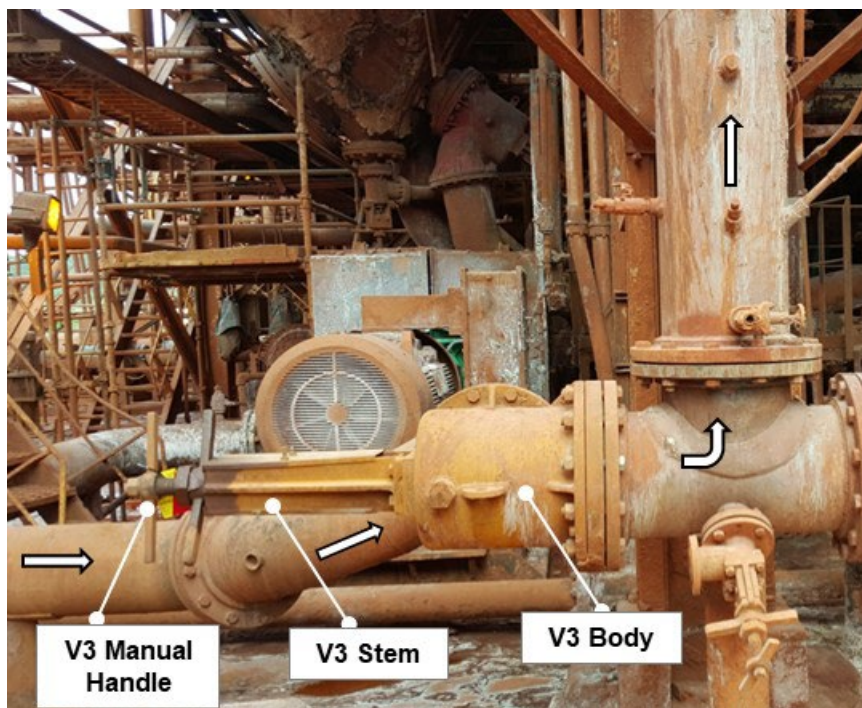
Figure 5. Expanded view of Fig. 4 showing more details on the #3 angle valve with flow direction arrows on piping – this view is when system is properly operating

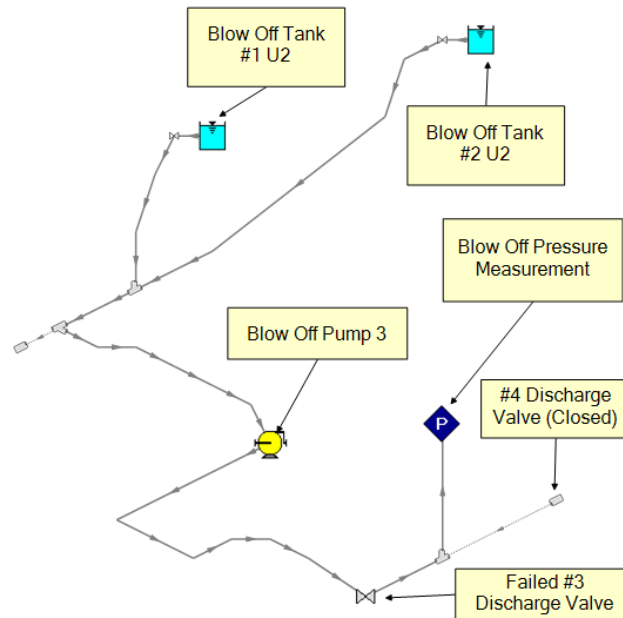
Shortly after the accident the second author was engaged to provide an independent failure assessment. At that time the second author contacted the first author's company to develop a waterhammer simulation to show the potential peak pressures. The simulation results are shown here and the model was recently updated to the latest version of the simulation software, *AFT Impulse* (4). As expected, results were similar to those in the original study performed in 2016. Fig. 15 shows the updated model.

The blow-off tanks were modelled as atmospheric pressure and 20 ft (6 m) liquid surface level. The DBO pump and valve were at 4 ft (1.2 m). The blow-off pressure measurement (PT in Fig. 3) was set to 58 psig (4 bar-g) at an elevation of 3.5 ft (1 m) higher than the valve. The initial flow rate through the pump was 4250 gpm (965 m³/hr).

Figure 15. Waterhammer model of Unit 2 DBO slurry piping
